# Recreational Use Attainability Analysis for White Oak Creek (0303B) in the Sulphur River Basin

Prepared for:  
Texas State Soil and Water Conservation Board  
Project 16-60

Texas Institute for Applied Environmental Research  
Tarleton State University  
Stephenville, Texas

TR1708

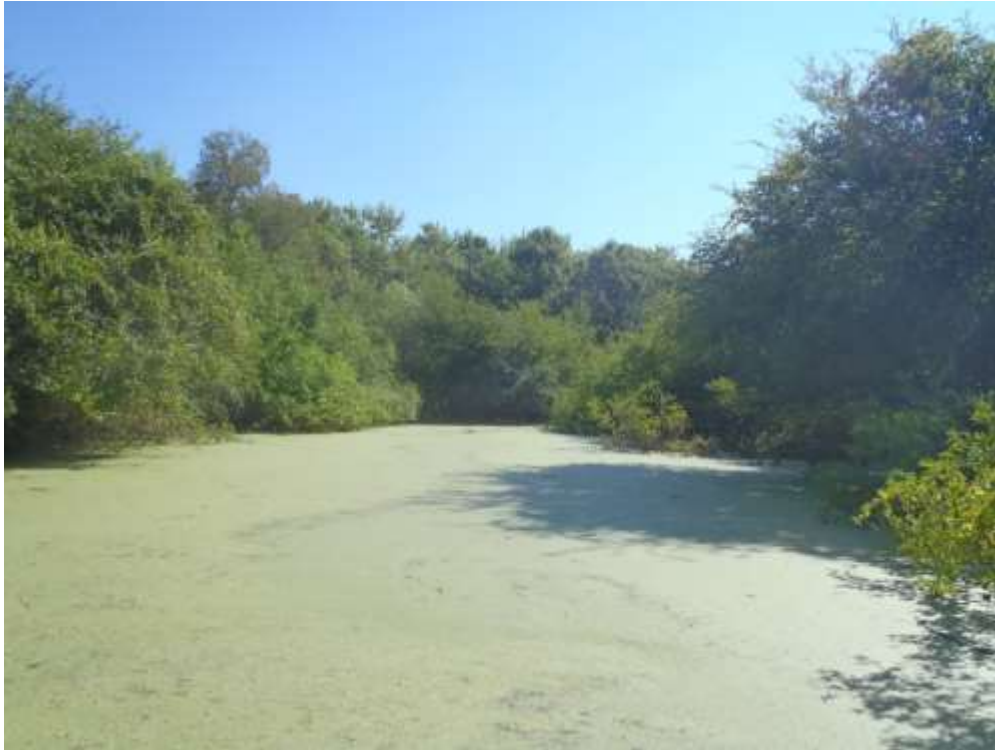
**Figure 4.2**      **Photograph of White Oak Creek Site WH01 taken on July 19, 2016. The downstream view of the 150-m transect.**

The primary substrate seemed to be mud/clay with fine sediment bottom deposit (Table 4.5). During the first survey, aquatic vegetation was abundant, primarily in the form of duckweed as can be seen in Figure 4.2. However, during the second survey, aquatic vegetation was still common but not nearly as copious as in the previous survey (Figure 4.3). During both surveys, the water color was clear with some floating and submerged debris while algae cover and odor remained rare.

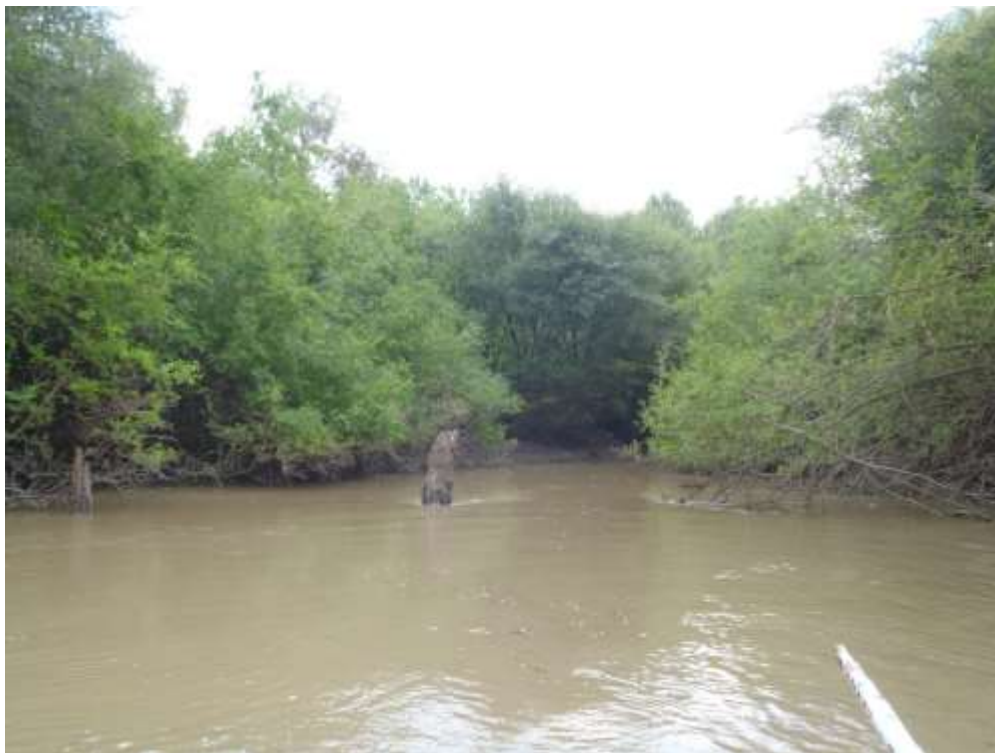
**Figure 4.3** Photograph of White Oak Creek Site WH01 taken on August 25, 2016. The downstream view of the 150-m transect.

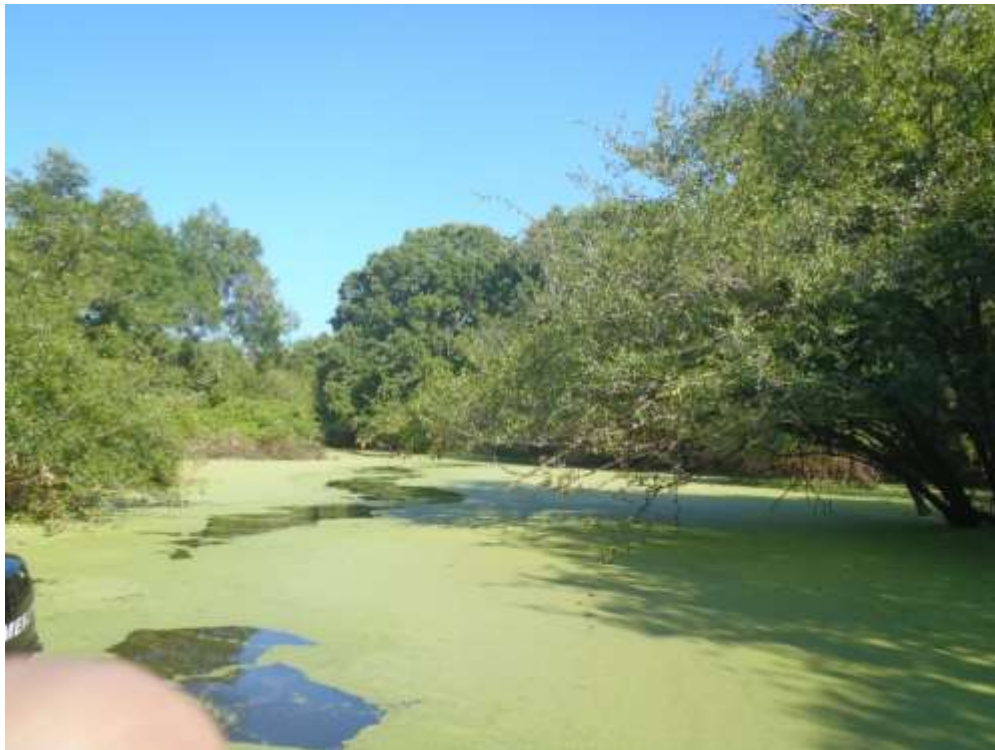
**Figure 4.4** Photograph of White Oak Creek Site WH02 taken on July 19, 2016. The upstream view of the 150-m transect. TIAER personnel in photo.

The primary substrate seemed to be mud/clay with fine sediment bottom deposit (Tables 4.5 and 4.9). During the first survey aquatic vegetation was abundant, primarily in the form of duckweed as can be seen in Figure 4.4. During the second survey, aquatic vegetation was absent (Figure 4.5). Algae cover was rare during the first survey and absent during the second. The water color was clear with some floating and submerged debris and odor remained rare during both surveys.

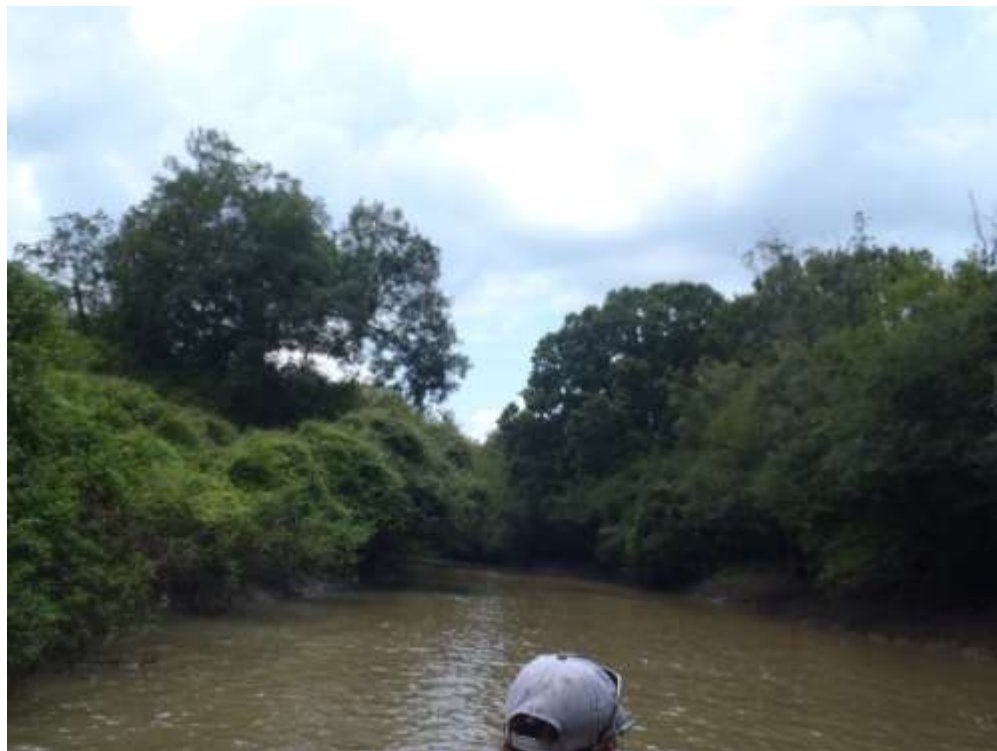
**Figure 4.5** Photograph of White Oak Creek Site WH02 taken on August 25, 2016. The upstream view of the 150-m transect. TIAER personnel in photo.

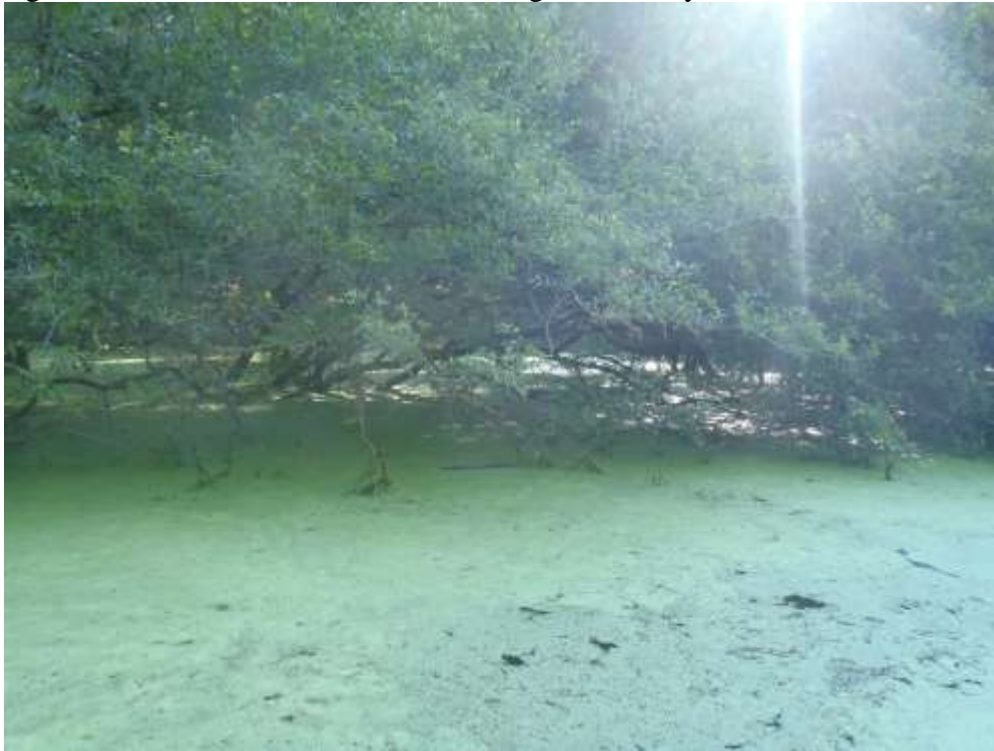
**Figure 4.6** Photograph of White Oak Creek Site WH03 taken on July 19, 2016, the left bank view of the 150-m transect.

The primary substrate seemed to be mud/clay with fine sediment bottom deposit (Table 4.5 and 4.9). During the first survey aquatic vegetation was abundant, primarily in the form of duckweed as can be seen in Figure 4.6. During the second survey, aquatic vegetation was absent (Figure

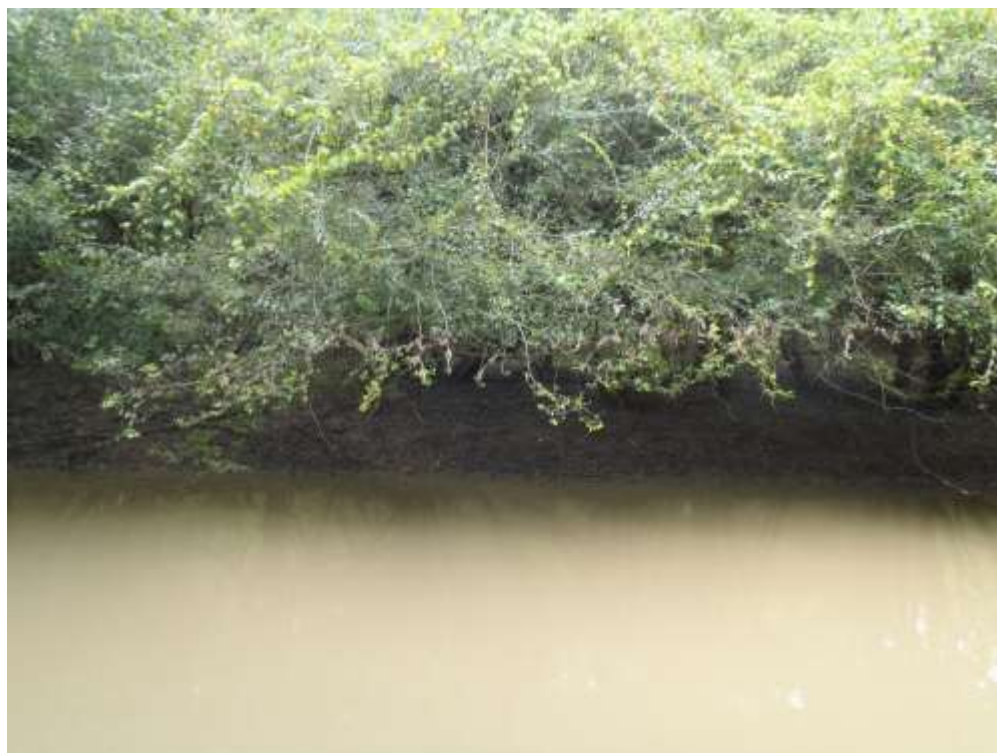
**Figure 4.7**      **Photograph of White Oak Creek Site WH03 taken on August 25, 2016, the left bank view of the 150-m transect.**

4.7) Algae cover was absent during both surveys. The water color was clear with some floating and submerged debris and odor remained rare during both surveys.

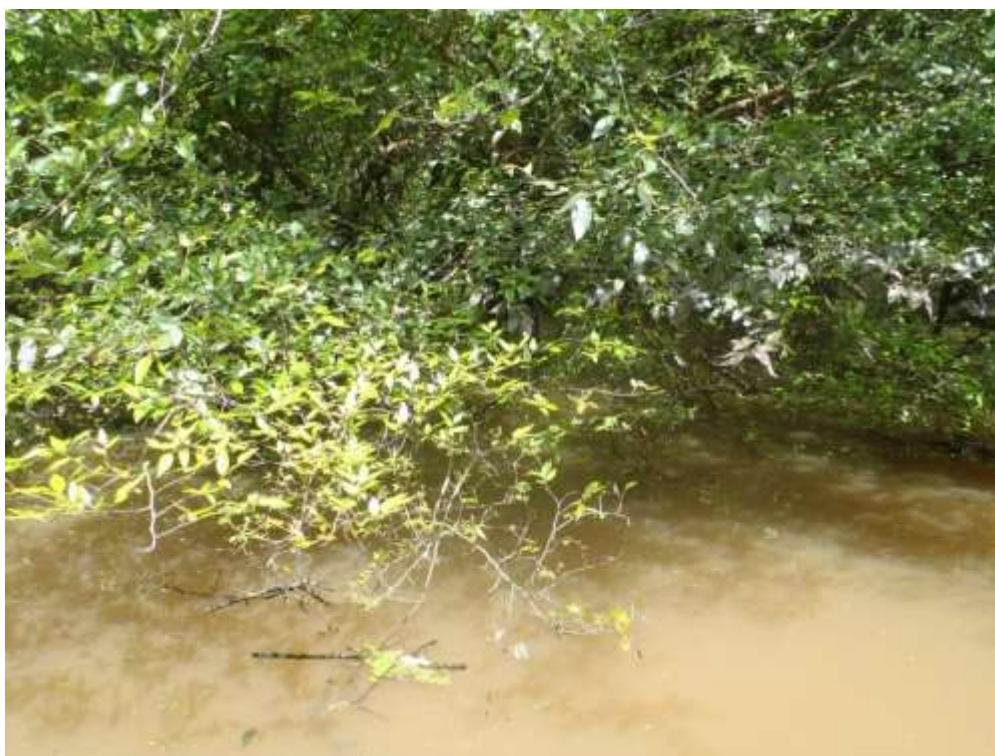
**Figure 4.8** Photograph of White Oak Creek Site WH05 taken on June 23, 2016, the left bank view of the 0-m transect.

During the first survey, the creek was out of its banks and the edge of water extended into the flooded vegetation out of visible range at all 11 transects (Figure 4.8). Where a definitive width measurement was not possible, width measurements were recorded as the greatest visible distance of water between left and right banks. During the first survey the greatest width was estimated at 51 m, the narrowest was estimated at 30 m with an estimated typical width of 35 m (Tables 4.7 and 4.8). During the second survey the creek was back down within the main channel and both banks were visible (Figure 4.9). Widths ranged from 35 m to 18 m with a typical observed width of 30 m.

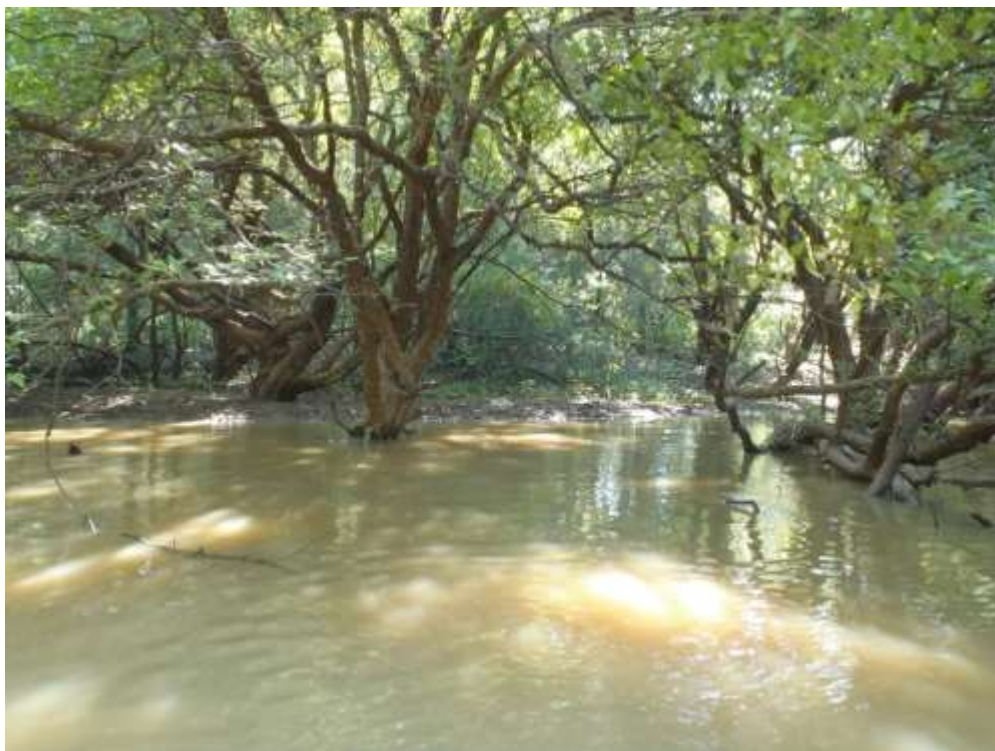
**Figure 4.9**      **Photograph of White Oak Creek Site WH05 taken on August 25, 2016, the left bank view of the 0-m transect.**

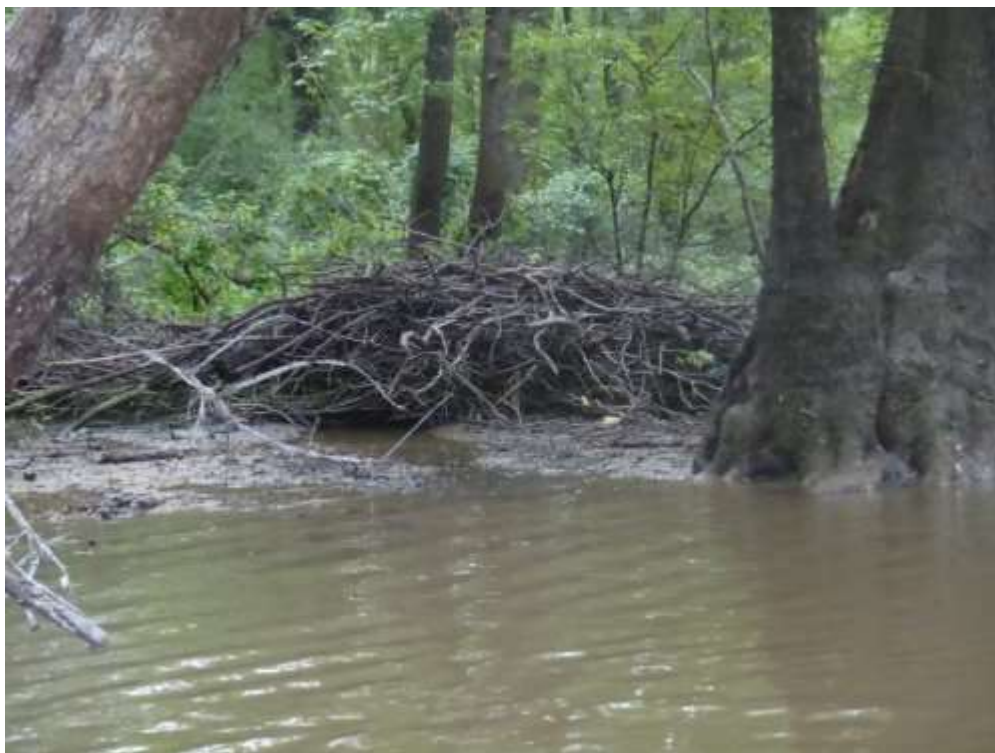
**Figure 4.10** Photograph of White Oak Creek Site WH05 taken on June 23, 2016, a river otter lodge on the right bank.

Small fish, turtles, and a snake were observed at this site and the call of a great blue heron was heard. During first survey and while traveling between WH06 and WH05, a river otter (*Lontra canadensis*) den was observed on the left bank (Figure 4.10). Although it was not located within the 300-m reach of Site WH05, given that river otters can range from 1.2 – 17 miles within a waterway, it is important to report their presence within this portion of the White Oak Creek corridor.

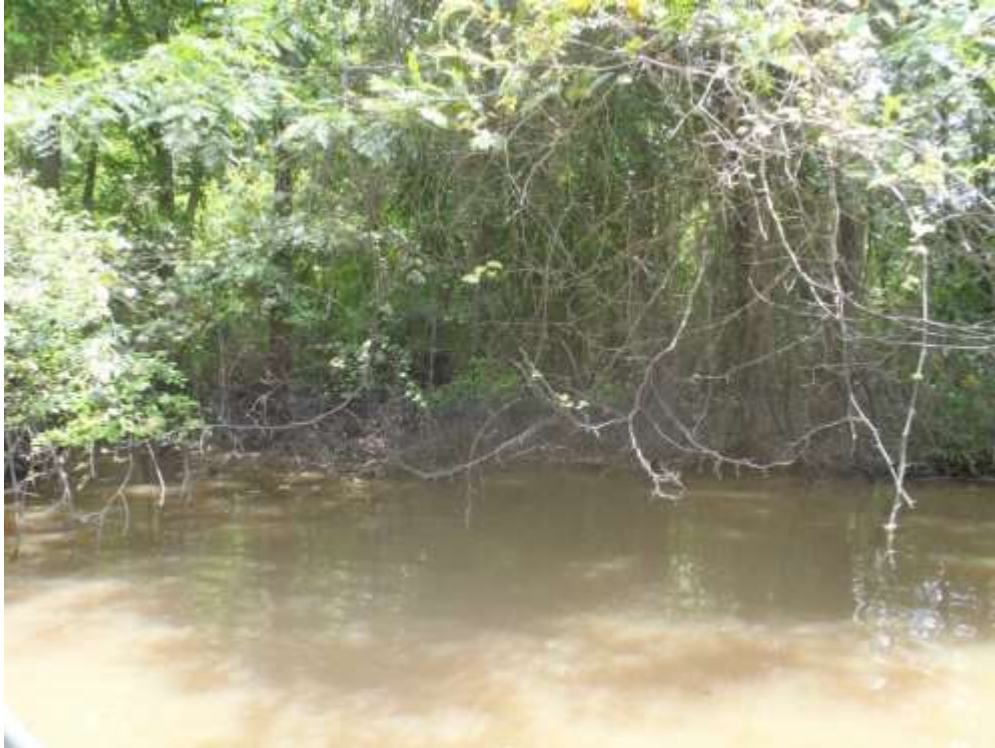
**Figure 4.11** Photograph of White Oak Creek Site WH06 taken on June 23, 2016, the right bank view of the 300-m transect.

White Oak Creek at site WH06 was visited on June 23 and August 25, 2016. This site was located 8.59 miles from the confluence with the Sulphur River and 0.6 mile upstream from WH05. Bank access was unattainable during the first survey as they were submerged and the canopy of the understory trees blocked any travel to the edge of the water. During the first survey, the creek was out of its banks and the edge of water extended into the flooded vegetation out of visible range at 7 of the 11 transects (Figure 4.11). Where a definitive width measurement was not possible, width measurements were recorded as the greatest visible distance of water between left and right banks. During the first survey, the maximum width of the stream was estimated at 70 m, the narrowest was estimated at 20 m with an estimated typical width of 37 m (Table 4.7). During the second survey, the creek was back down within the main channel and both banks were visible for width measurements (Figure 4.12). Widths during this time ranged from 20 m to 12 m with a typical observed width of 17 m (Table 4.8).

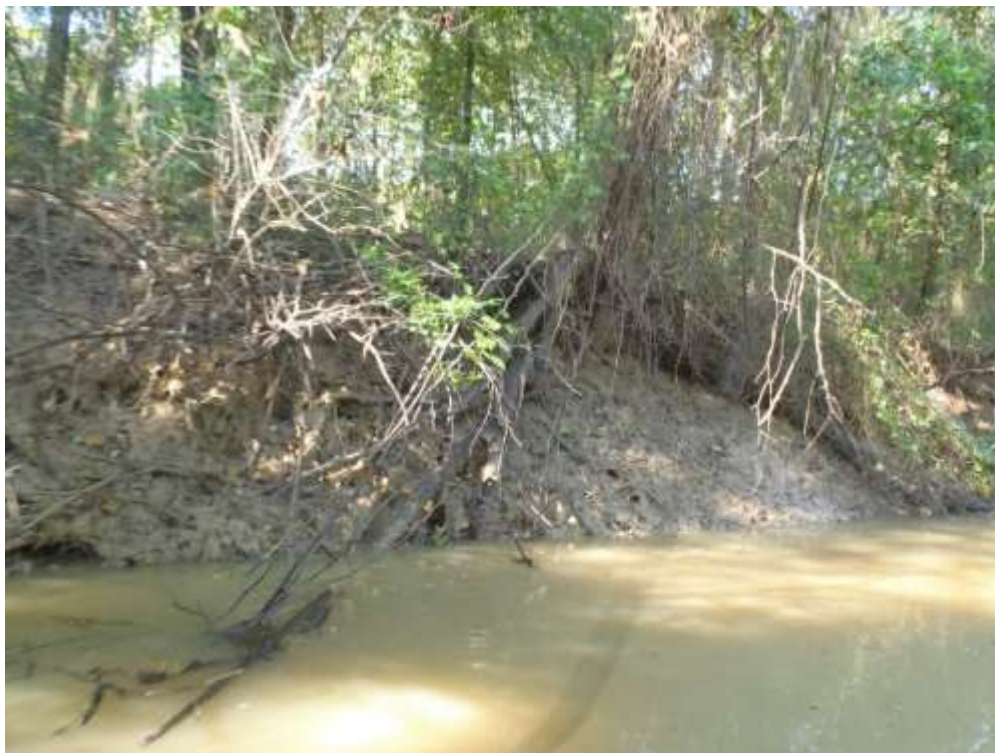
**Figure 4.12** Photograph of White Oak Creek Site WH06 taken on August 25, 2016, the right bank view of the 300-m transect.

Thalwegs during both surveys were greater than 1.5 m rendering the creek at this site non-wadeable (Table 4.6). The dominant substrate of the stream at this site was mud/clay (Table 4.5). Duckweed was common on the water surface during both surveys. No algae or odor were detected at this site and the bottom deposits were of fine sediment (Tables 4.9 and 4.10). The color of the water was brown and clear of scum or foam during both surveys, however floating debris was excessive during the second survey.

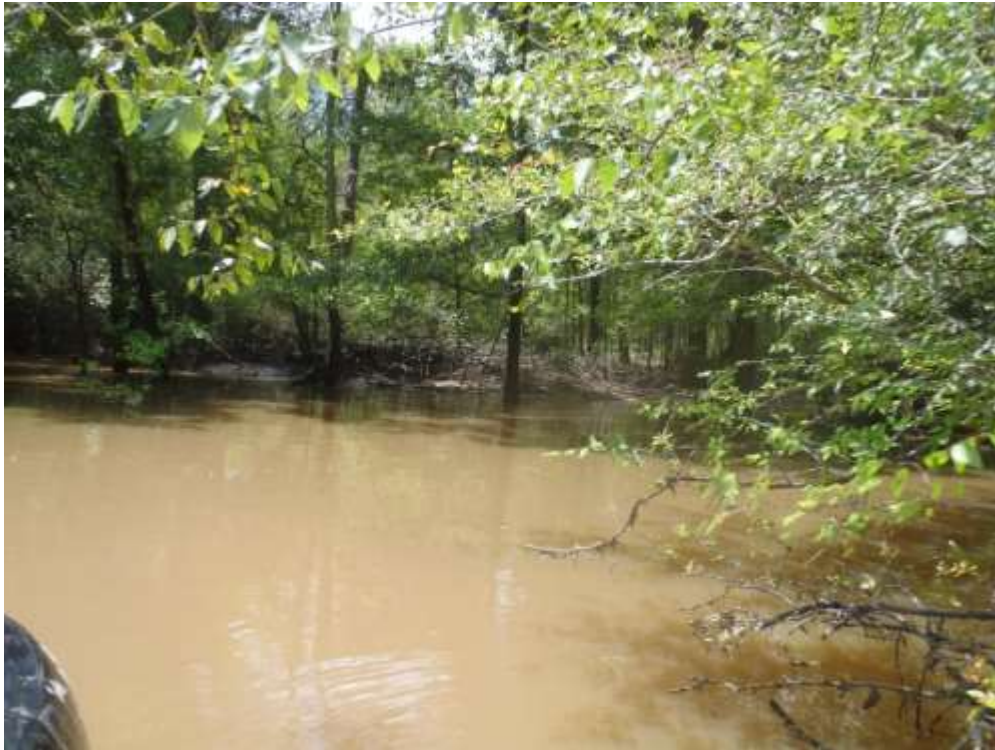
**Figure 4.13** Photograph of White Oak Creek Site WH07 taken on June 23, 2016, the left bank view of the 300-m transect.

White Oak Creek at site WH07 was surveyed on June 23 and August 25, 2016. This site was located 9.86 miles from the confluence with the Sulphur River and 1.27 miles upstream from WH06. Bank access was unattainable during the first survey as the banks were submerged and the canopy of understory trees blocked any travel to the edge of the water. During the first survey, the creek was out of its banks and the edge of water extended into the flooded vegetation out of visible range at 7 of the 11 transects (Figure 4.13). Where a definitive width measurement was not possible, width measurements were recorded as the greatest visible distance of water between left and right banks. The maximum width of the stream was estimated at 30 m, the narrowest was estimated at about 15 m with an estimated typical width of 30 m (Table 4.7). During the second survey, the creek was back down within the main channel and both banks were visible for width measurements (Figure 4.14). Widths during this time ranged from 32 m to 19 m with a typical observed width of 22 m (Table 4.8).

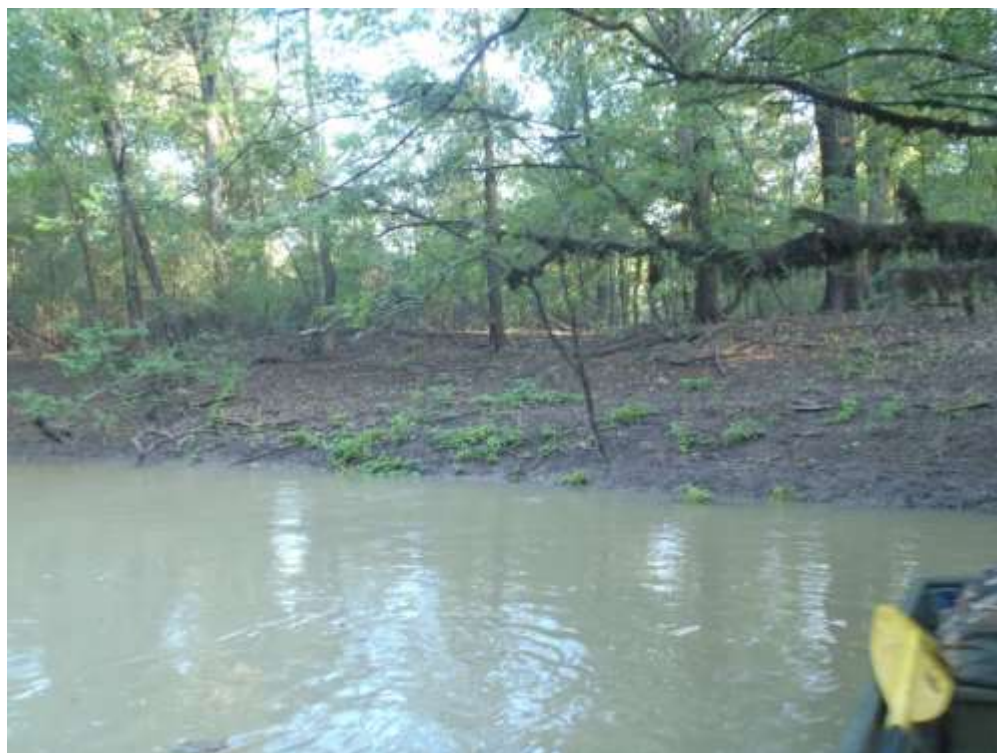
**Figure 4.14** Photograph of White Oak Creek Site WH07 taken on August 25, 2016, the left bank view of the 300-m transect.

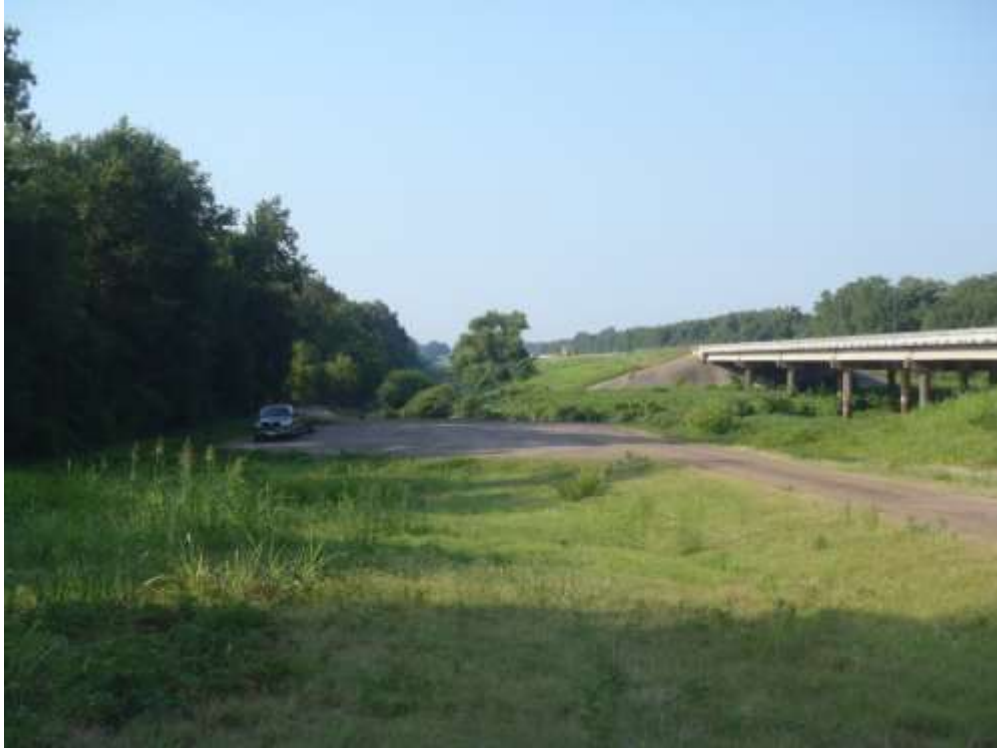
**Figure 4.15** Photograph of White Oak Creek Site WH08 taken on Saturday, July 23, 2016 (a “peak recreation time”). Photo of the paved parking lot access point at US Hwy 259.

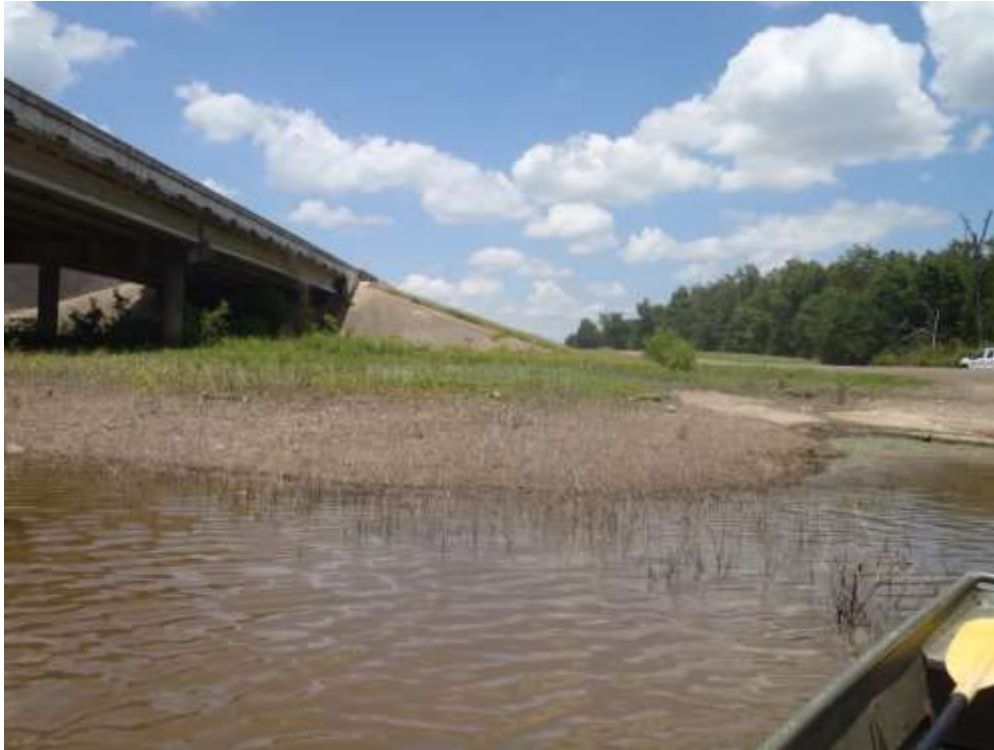
**Figure 4.16** Photograph of White Oak Creek Site WH08 taken on June 23, 2016, the left bank view of the 150-m transect and access to creek from parking lot.

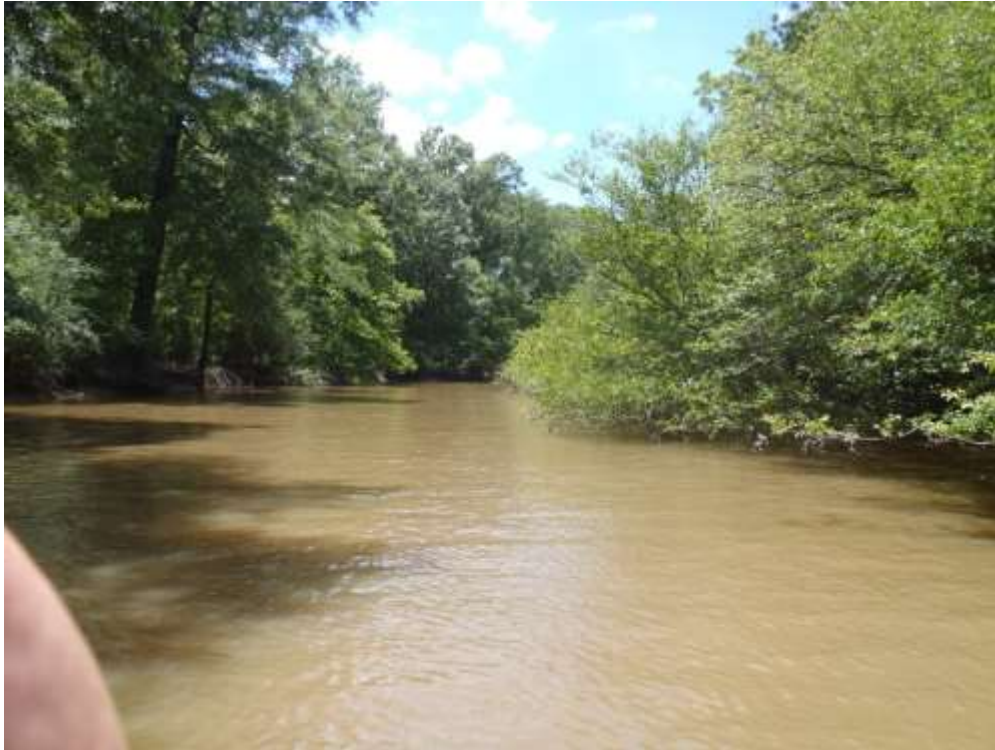
**Figure 4.17** Photograph of White Oak Creek Site WH08 taken on June 23, 2016, the upstream view of the 300-m transect.

Thalwegs during the first survey were greater than 1.5 m rendering the creek at this site non-wadeable (Table 4.6). Wading was possible but challenging during the second survey. Average thalweg during the second survey was 1.1 m, however, a maximum depth of 1.4 m pushed the limits of wadeable due to varying heights of field personnel. The dominant substrate of the stream at this site was mud/clay (Table 4.5). Aquatic vegetation was rare, algae cover was absent, there was no odor detected and the bottom deposits were of fine sediment. (Tables 4.9 and 4.10). The color of the water was brown and clear of scum or foam during both surveys (Figures 4.17 and 4.18).

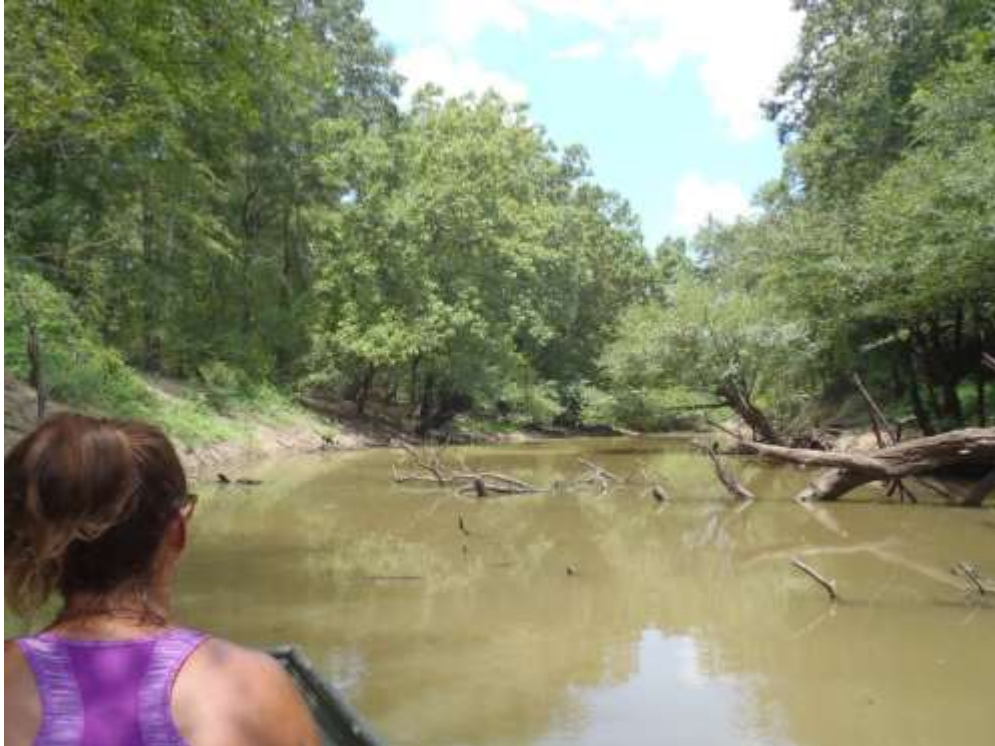
**Figure 4.18** Photograph of White Oak Creek Site WH08 taken on August 11, 2016, the upstream view of the 300-m transect. TIAER personnel in photo.

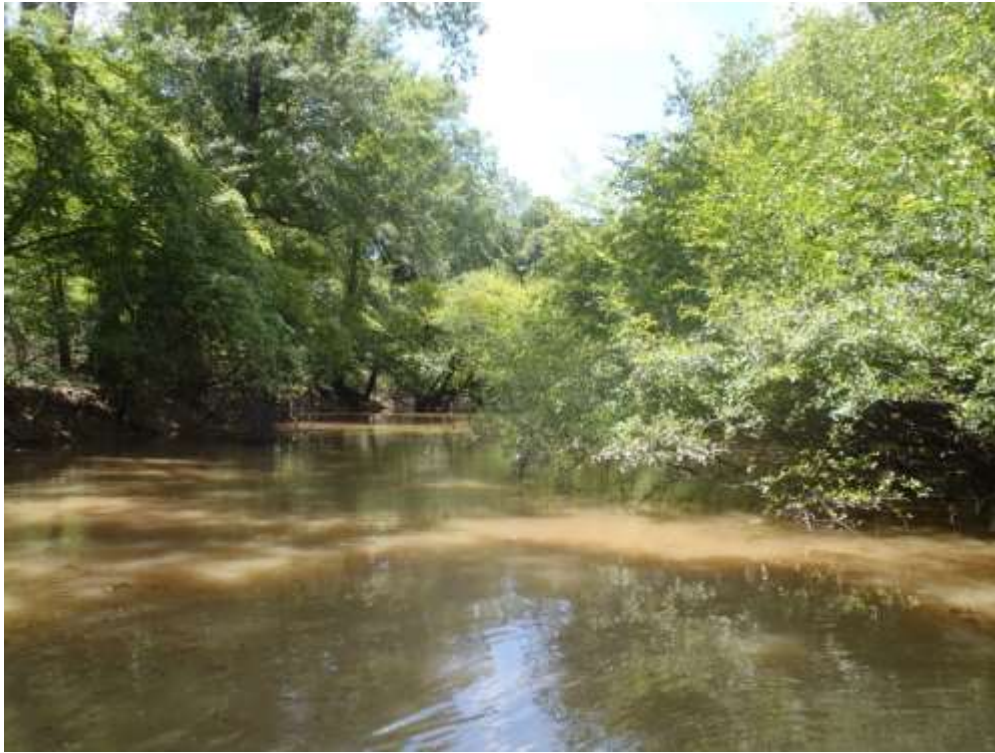
**Figure 4.19** Photograph of White Oak Creek Site WH09 taken on June 23, 2016, the upstream view of the 150-m transect.

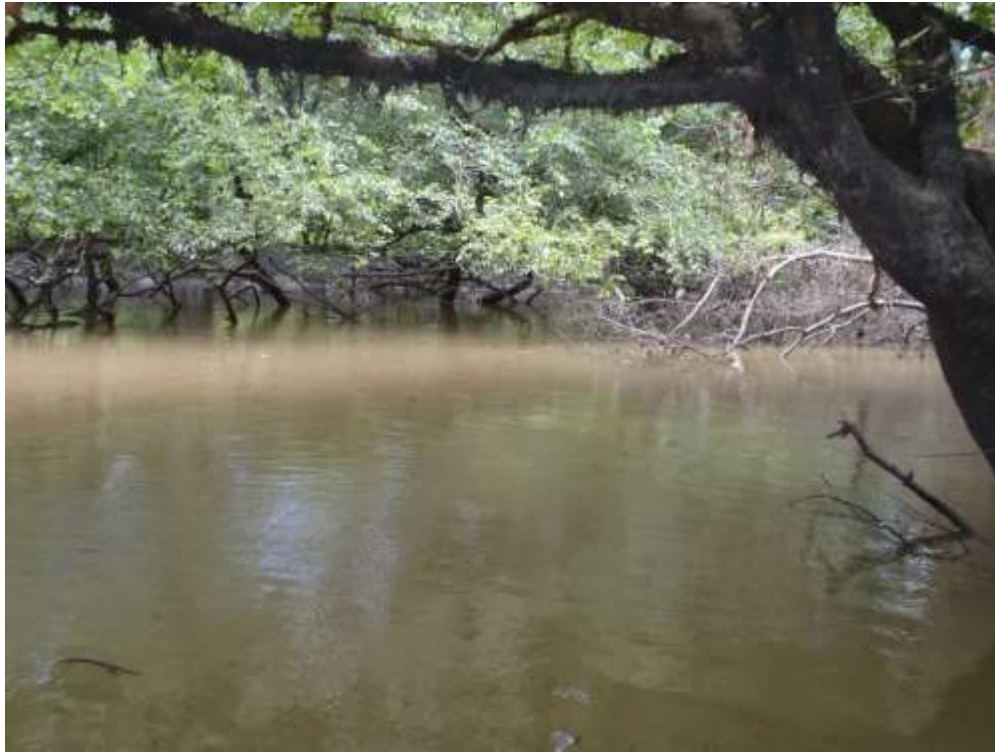
**Figure 4.20** Photograph of White Oak Creek Site WH09 taken on June 23, 2016, the right bank view of the 300-m transect.

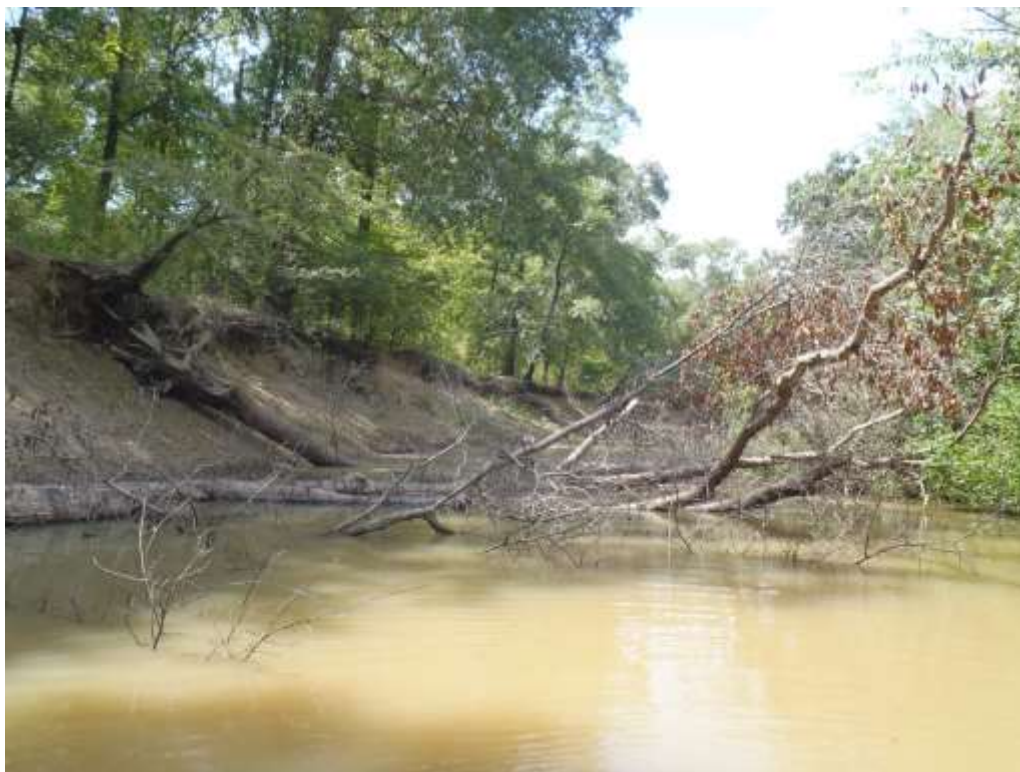
**Figure 4.21** Photograph of White Oak Creek taken on August 11, 2016, the upstream view at the logjam preventing access to WH09.

White Oak Creek at site WH09 was surveyed June 23, 2016 and attempted on August 11, 2016. This site is located 11.98 miles from the confluence with the Sulphur River and 1.28 miles upstream from site WH08. This site exists within the WMA with a corridor dominated by dense native forest on both sides (Table 4.5). Access to this site was moderately difficult as it was only accessible by boating upstream from US Hwy 259 (Table 4.11). While this site was accessible for the first survey (Figures 4.19 and 4.20), access was attempted but unattainable during the second survey trip because lower water levels combined with logjams and fallen trees across the channel impeded travel by boat to the site. Additionally, dense bank vegetation and slick, steep muddy banks prohibited walking to the site (Figure 4.21). No second survey was conducted.

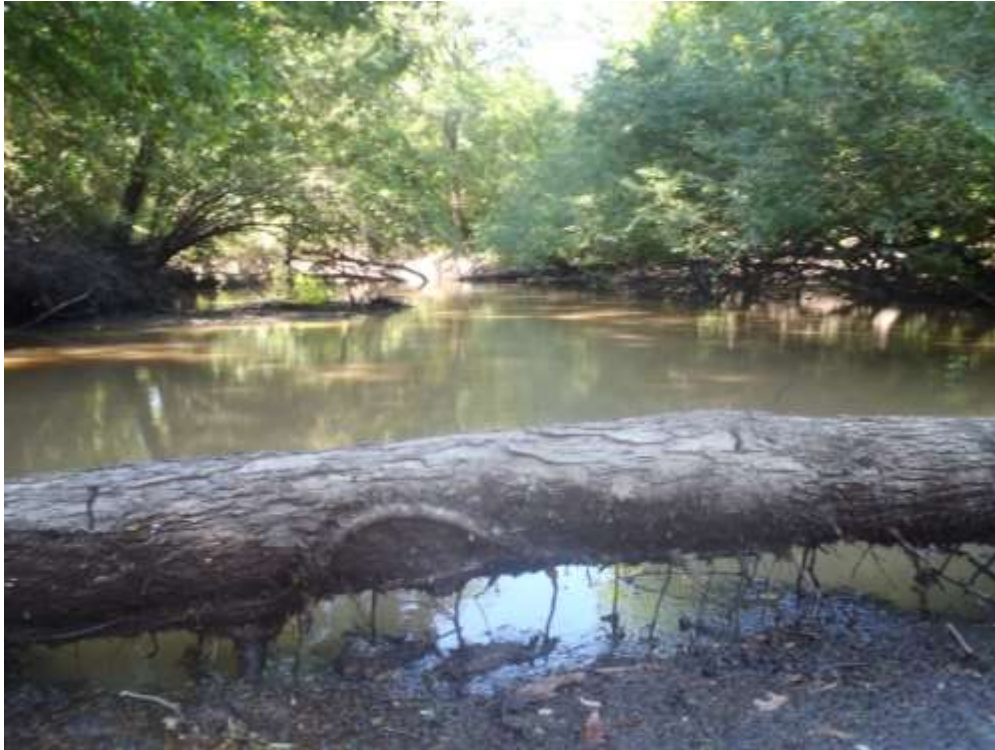
**Figure 4.22** Photograph of White Oak Creek Site WH11 taken on June 23, 2016, of logjam-A and the downstream view of the 0-m transect.

Sites WH10 – WH15 were only accessible by boat launched from the Hill Hole bridge within the WMA at site WH14 (Table 4.11). Two logjams had a significant effect on accessibility of sites WH10 – WH12 during the 2016 sampling period. During the first survey, logjam-A (Figure 4.22) prevented TIAER personnel from reaching the original coordinates for WH11. Consequently WH10 was also inaccessible since it was downstream from WH11 and there was no access point that would allow access to WH10 from downstream. A new waypoint for WH11 was created at the logjam and an RUAA was conducted from that point since it was an adequate distance from WH12.

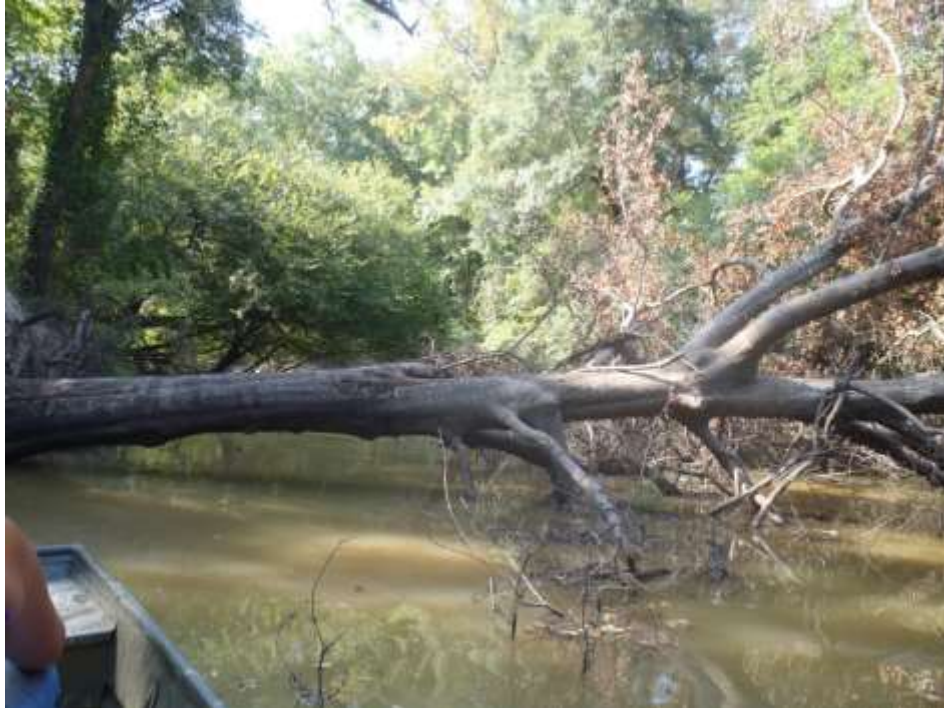
**Figure 4.23** Photograph of White Oak Creek between WH12 and WH13 taken on August 11, 2016, of logjam-B.

During the second survey, a fallen tree created logjam-B (Figure 4.23) which was encountered between WH12 and WH13 and upstream from logjam A. Logjam B existed during the first survey but higher water levels allowed TIAER personnel to exit the boat onto the tree trunk, drag the boat across the fallen tree, and continue downstream. Lower water levels during the second survey prevented dragging the boat over and were too high to allow the boat to pass under the tree trunk. Every effort was made to bypass the logjam on the both left and right banks and to pass the boat beneath the log. The left bank was accessible but dense vegetation restricted access further along the banks. Dense vegetation on the right bank restricted access to the banks from the stream. The boat motor would not fit under the fallen tree (Figure 4.24 and 4.25). As a result, this logjam prevented access to WH12, WH11, and WH10 during the second survey. The physical descriptions of the first surveys of WH11 and WH12 and associated photographs follow.

White Oak Creek at site WH11 was accessed on June 23, 2016 and attempted on August 11, 2016. A second survey was not conducted due to the aforementioned reasons. This site is located 17.9 miles from the confluence with the Sulphur River and about 6 miles upstream from WH09, the nearest reachable downstream site. Stream channel and corridor characteristics were identical to WH09 (Table 4.5). Banks were steep and slippery. Accessibility was moderately difficult given the roughly 3-mile boat ride from the public boat ramp at Hill Hole and the need to drag the boat across a large logjam (Figures 4.23 and 4.24).

White Oak Creek at site WH12 was accessed on June 23, 2016 and attempted on August 11, 2016. A second survey was not conducted due to the aforementioned reasons. This site is located 19.43 miles from the confluence with the Sulphur River. Stream corridor was densely forested on both sides (Table 4.5 and Figure 4.28). Banks were steep and slippery. Accessibility was difficult given the roughly 1.6 mile boat ride from the public boat ramp at Hill Hole and the need to drag the boat across a large logjam (Figures 4.23 and 4.24). No other roads exist within the WMA to gain access to Site WH12.

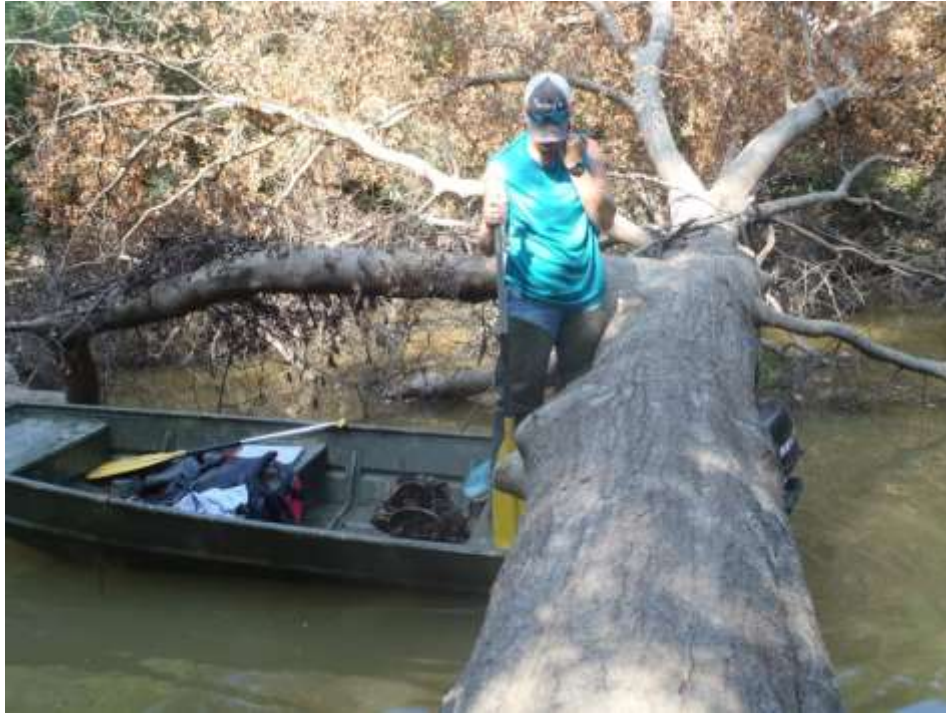
**Figure 4.24** Photograph of White Oak Creek between WH12 and WH13 taken on August 11, 2016, of logjam-B. Note, motor housing will not fit beneath log. TIAER personnel in photo.

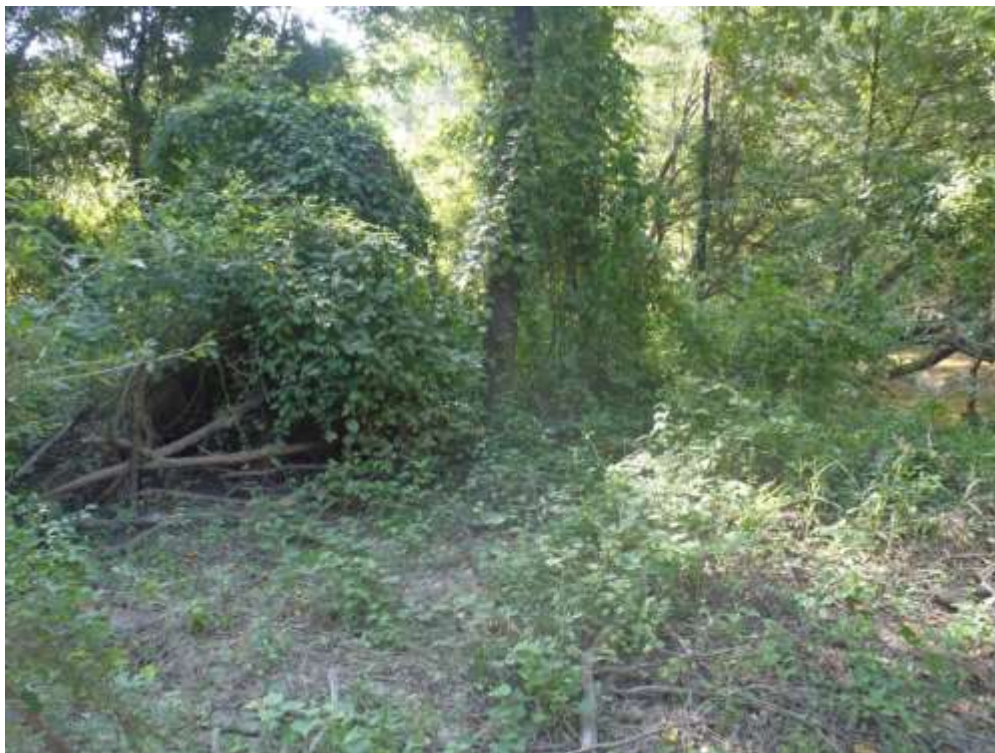
**Figure 4.25** Photograph of White Oak Creek between WH12 and WH13 taken on August 11, 2016 of the left bank. Thick bank vegetation prohibiting further access downstream to WH12.

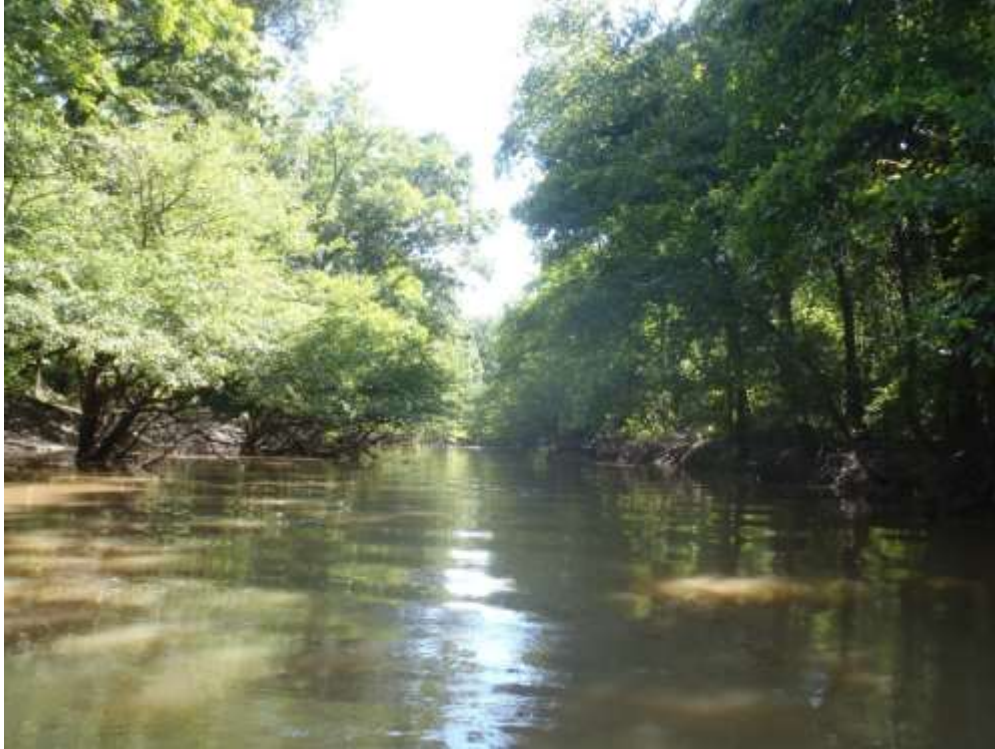
**Figure 4.26** Photograph of White Oak Creek Site WH11 taken on June 23, 2016. Upstream view of 300-m transect.

Aesthetic appearance of the water and wildlife observations for the site during each survey have been previously provided in Tables 4.9 and 4.10, respectively. The water at this site was brown in color with a bottom deposit of fine sediment (Figure 4.26). The surface was clear and no aquatic vegetation, algae, or odor was detected. A variety of wildlife was observed at this site including an owl in an overhanging tree and a water-dependent bird flying over the channel. A total of five
